Pink Inspection Services B&R

Visual Building Inspection Report

Property Inspected: XX

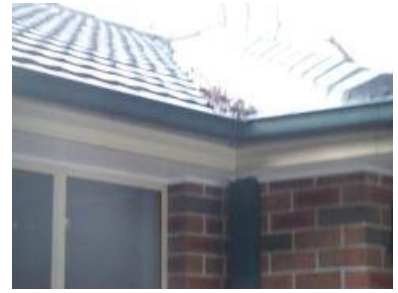
Condition: Leaves obstructed full inspection. These must be removed to enable a more complete inspection to be carried out and prevent water penetration into the eaves and ceiling areas.
Estimated cost for repairs from \$180.

Type of Defect The item or part does not function as expected.
The following action is recommended: A licensed roof plumber should be called to make a further evaluation and repairs or rectification as needed.

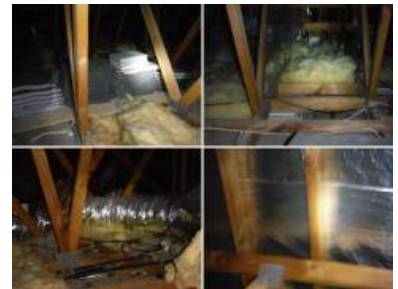
Inspection Restrictions: Sarking membrane and insulation is present in the roof cavity. This restricted inspection to some roofing timbers. Removal of insulation is not within the scope of a standard visual building inspection report. Ducting associated with air conditioning or heating restricted inspection. Where areas are restricted, removal of the restriction is required to enable a more complete report be submitted. Stored goods restricted inspection within this area.

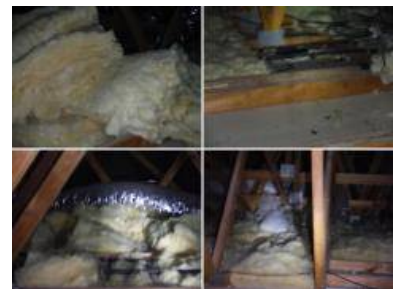
Insulation Status: The insulation is out of place and should be re distributed correctly. The insulation covers or is close to electrical items, such as down lights, recessed incandescent lights, recessed halogen lights, transformers, exhaust fans etc. This is a potential fire risk and we strongly recommend inspection by a licensed electrician. There is insulation provided to some sections of the ceiling cavity.

The following action is recommended: A licensed builder should be called to make a further evaluation and repairs or rectification as needed. An electrician should be called to make a further evaluation and repairs or rectification as needed. A tiler should be called to make a further evaluation and repairs or rectification as needed.

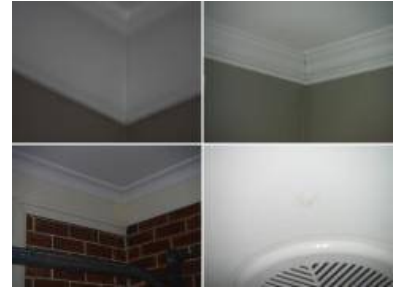
The condition of the ceilings is generally fair. Moderate cracking is present to cornices. This will require maintenance. Nails are popping and are visible. This is generally due to movement in the timber framing. Periodic maintenance may be required and ceilings may need to be re-secured. **Estimated cost for repairs from \$700.**

A plasterer should be called to make a further evaluation and repairs or rectification as needed. A Licensed painter should be called to make a further evaluation and repairs or rectification as needed.

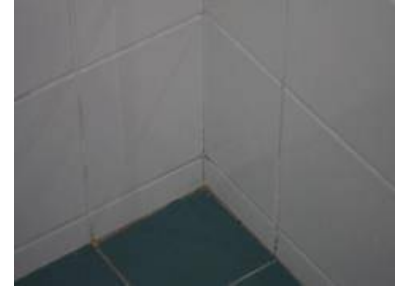
The condition of the tiles is generally fair. A flexible sealant should be provided to the gaps between tiled corners or areas to provide an acceptable finish and prevent water penetration.

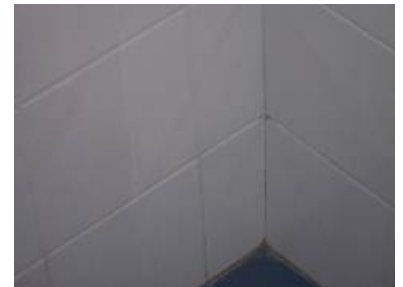
The condition of the tiles is generally fair. A flexible sealant should be provided to the gaps between tiled corners or areas to provide an acceptable finish and prevent water penetration.

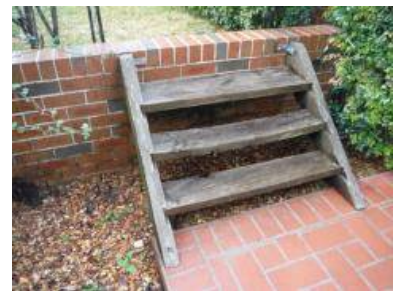
Wood Decay: Minor wood decay damage was noted. Maintenance and repair is required.

The following action is recommended: A licensed carpenter should be called to make a further evaluation and repairs or rectification as needed.

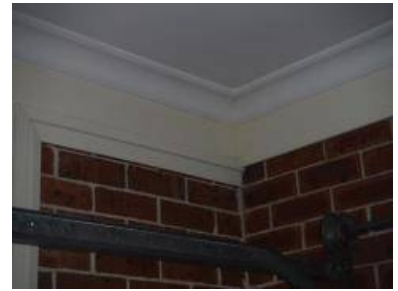
The condition of the ceilings is generally fair. Moderate cracking is present to cornices. This will require maintenance.
Estimated cost for repairs from \$220.

A Licensed painter should be called to make a further evaluation and repairs or rectification as needed.

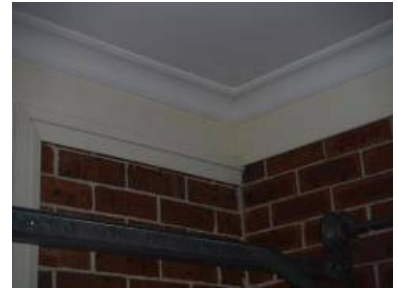
The condition of the walls is generally fair. Minor cracking is evident to wall linings. Periodic maintenance may be required.
Estimated cost for repairs from \$220.

A Licensed painter should be called to make a further evaluation and repairs or rectification as needed.

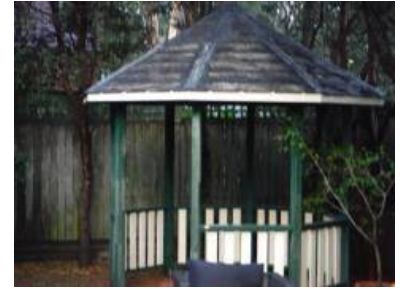
The condition of the walls is generally fair. Paint deterioration was present to external surfaces. Maintenance and/or repairs will be required. **Estimated cost for repairs from \$300.**

A Licensed painter should be called to make a further evaluation and repairs or rectification as needed.

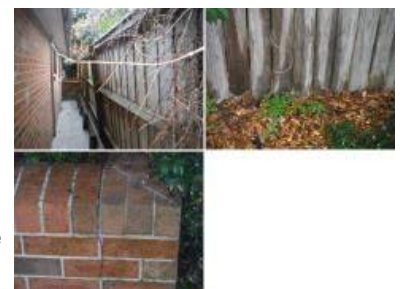
Left hand side: Rear section:

The fences are mainly constructed from brick. The fences are generally in fair condition but some repairs or maintenance if required. Some cracking noted.
