Visual Timber Pest Inspection Report

VISUAL TIMBER PEST INSPECTION REPORT as per AS4349.3-2010

DATE OF INSPECTION: 25TH AUGUST 2016.

Building type: Single storey dwelling.

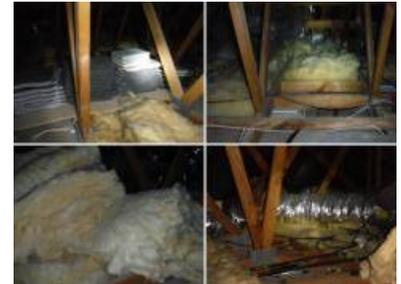
Insulation is present in the roof cavity. This restricted inspection to some roofing timbers. Removal of insulation is not within the scope of a standard visual timber pest inspection report however, this would be necessary for a more

complete report to be submitted.

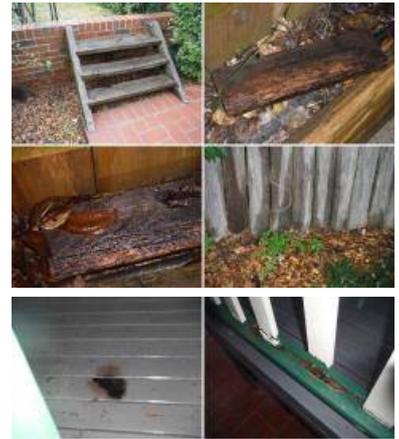
Description Yes - Fungal Decay (wood rot) was noted to the following timbers/areas.

Affected external timbers

Fencing timbers: Sleepers or timber landscaping materials: Various external timbers: Decking timbers: Steps/stair timbers:

Visible timber damage appears moderate to severe. Refer to the definitions section of this report - Section 1.6 - Timber Damage.

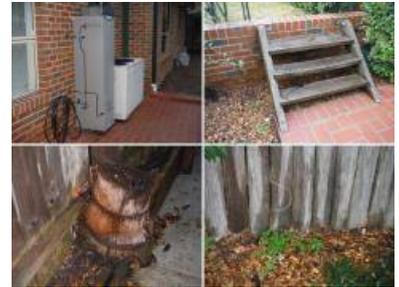
The air-conditioning condenser discharges adjacent to the external walls. We recommend modification so that water is discharged over a drain. Air conditioning units which release water alongside or near to building walls should be piped to a drain (if not possible then several meters away from the building) as the resulting wet area is highly conducive to termites.

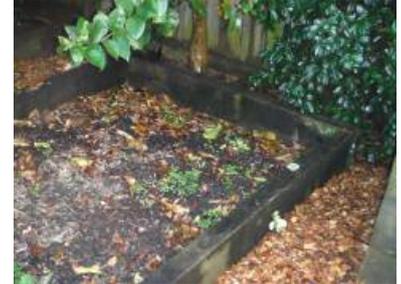
Description of Restriction: Inspection to the following fencing timbers was restricted in part by foliage - Various fencing timbers:

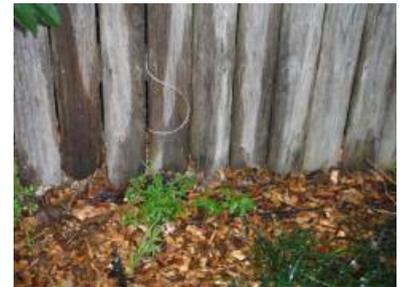
Conducive Conditions: Gardens or soil have been built up against the base of fences in some areas. This build up can conceal current timber pest attack and significantly increases the risk of future attack. Gardens and soil should not be built up against fencing timbers and we recommend modifications be made.

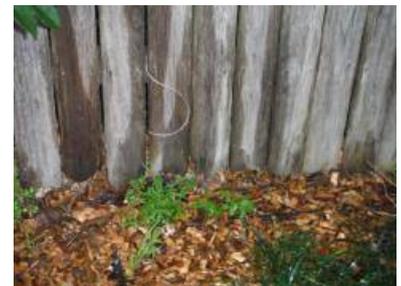
Description Yes - Wood decay damage was noted to the following timbers/areas.

Affected fence timbers Left hand side: Rear fence:

Severity Visible timber damage appears moderate. Refer to the definitions section of this report - Section 1.6 - Timber Damage.

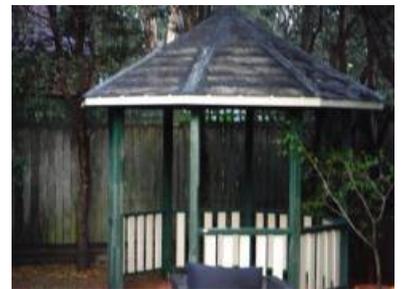
Description of Outbuilding A Gazebo:
Position/Location: To the rear of the property.
Evidence of active timber pests: No Timber Pest activity was detected to visible and accessible timbers at the time of the inspection.
Conducive Conditions Some timbers are in contact with soil. These should be modified so that timber to soil contact does not occur.

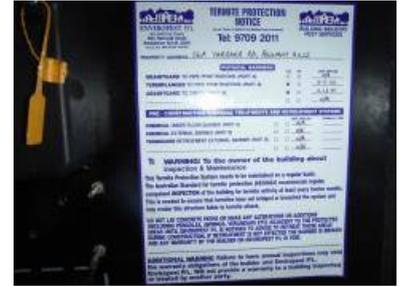
A notice indicates that the property may have been treated during construction in respect to protection against subterranean termite attack. We strongly recommend any prospective purchaser attempt to verify this information and obtain copies of all relevant documentation.
